LIGHT POLLUTION AND LIGHT WETTING ON CERAMIC (GLASS) INSULATORS AS A CAUSE OF UNKNOWN FLASHOVERS ON TRANSMISSION LINES.

FF Bologna, AC Britten, N Mahatho and *JP Reynders

South African High Voltage Engineering Centre (SAHVEC)
TSI, ESKOM Enterprises
South Africa

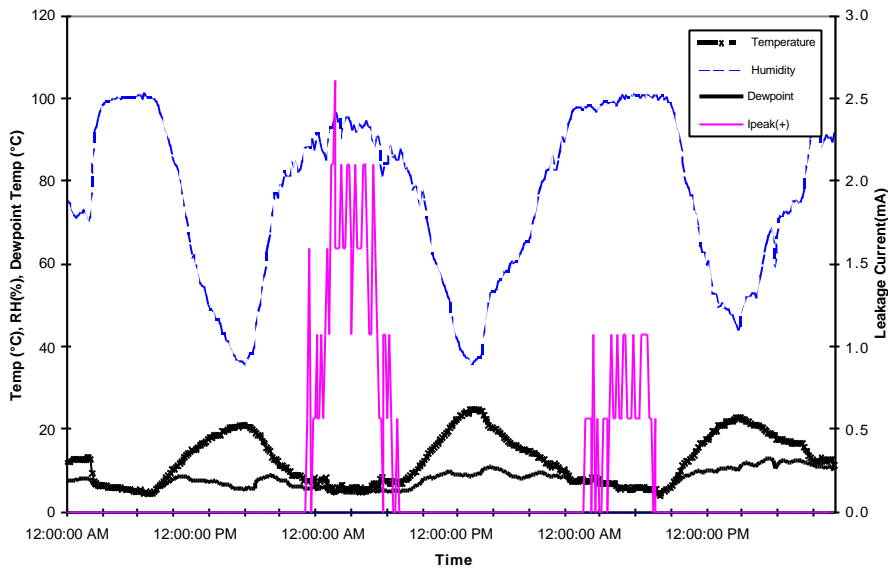
Figure 1: Relationship between rainfall, relative humidity, temperature and leakage current

Figure 1 shows an association between leakage current peaks (positive), relative humidity, temperature, dew point and time-of-day. The humidity/leakage current relationship is apparent. The increase in humidity to a value above 75% RH results in leakage current activity (3mA). This magnitude of leakage current is considered relatively small in comparison to levels expected under heavily polluted conditions. The time-of-day for this activity is typically between the hours of 21H00- 06H00.

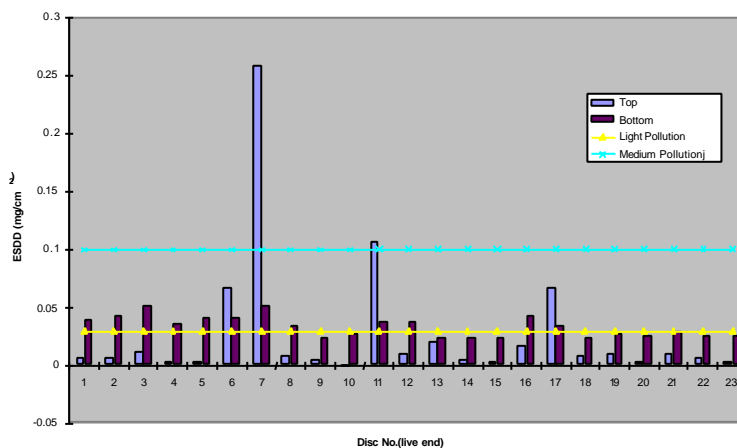
Figure 2: ESDD results (top and bottom separately)

Figure 2 shows that the general ESDD (pollution) levels on the strings are in the light to light-medium category. The high peaks seen on discs 7, 11 and 17, Figure 2 were due to bird pollution on the top sides of the discs. In general, the top sides of the discs were found to be much cleaner than the undersides, indicating the influence of natural washing by rain.

It is also evident that the pollution on the underside of the insulators varies according to the position in the string. Insulators on the live end tend to accumulate more pollution than on the dead side. Visual inspections of the discs also revealed, that, besides the occasional bird droppings, there were no other signs of severe bird pollution, tracking, flash marks or significant corrosion.

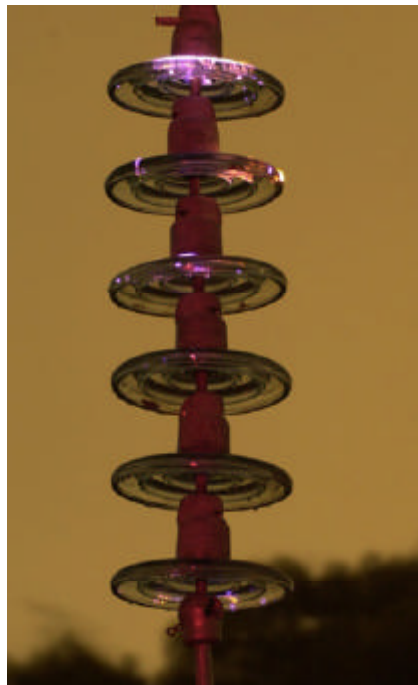
For this test the string was uniformly wetted/polluted. Approximately one minute after energisation micro-sparks were visible on the top and bottom sides on most of the discs. The discs furthest from the live end showed the most activity, whilst the live end disc showed less (see Figure 3). The electrical activity on the discs demonstrated the effect of partial drying/wetting of discs, which causes the voltage gradient across the string to become severely distorted. A typical waveform is shown in Figure 4.

Figure 3: Insulator String Uniformly Polluted/Wetted

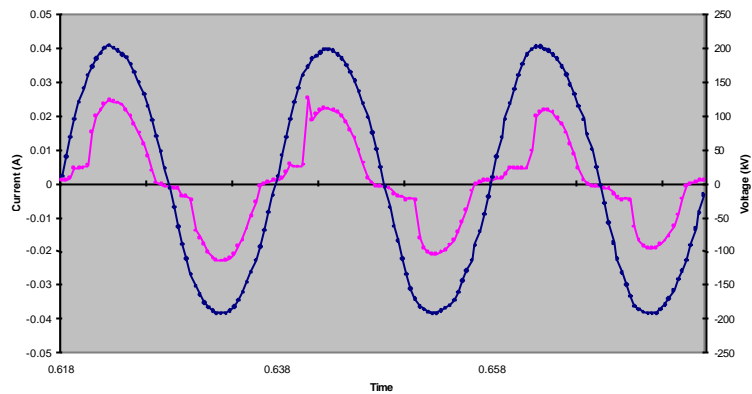
The waveform is typical of that of a polluted insulator. Both the leakage current and voltage are in phase indicating a resistive surface created by the "light" pollution layer. The maximum leakage current measured was about 25mA peak.

Figure 4: Typical waveforms for insulators shown in Figure3

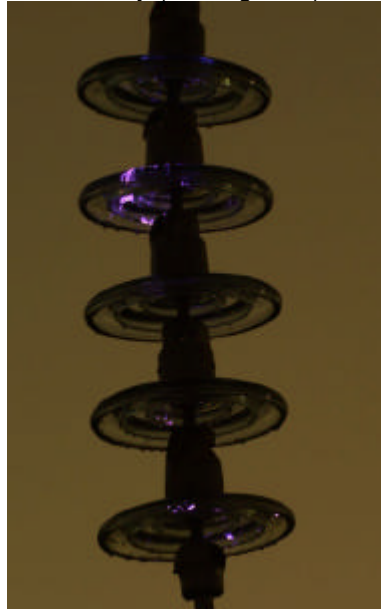
The bottom side of each disc was wetted/polluted whilst the top was kept dry. Micro-sparks were visible on both top and bottom sides on some of the discs. Like in previous tests, not all the discs showed signs of electrical activity (see Figure 5).

Figure 5: Non-Uniformly Polluted/ Wetted String (top side clean and dry)

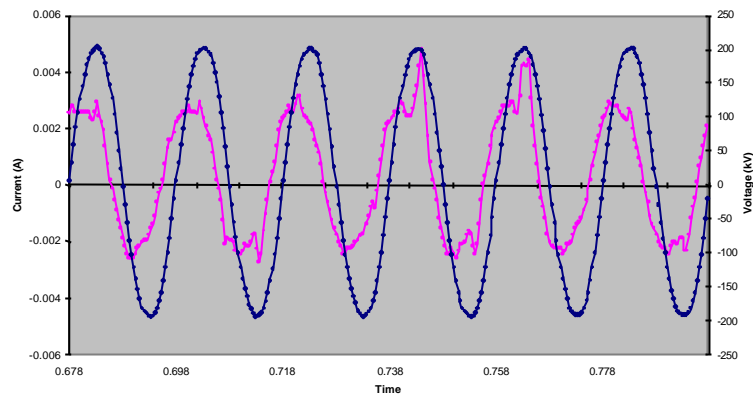
The magnitude of leakage current was small ($< 5\text{mA}$) and a phase shift is evident (see Figure 6). This indicates that the resultant leakage current across the string is largely capacitive and not resistive (the capacitance is created by the dry top-side of the disc.) The current waveform does, however contain transient current pulses on the peaks of the waveform indicating sparking somewhere along the string.

Figure 6: Typical Waveform for Insulator Shown in Figure 5

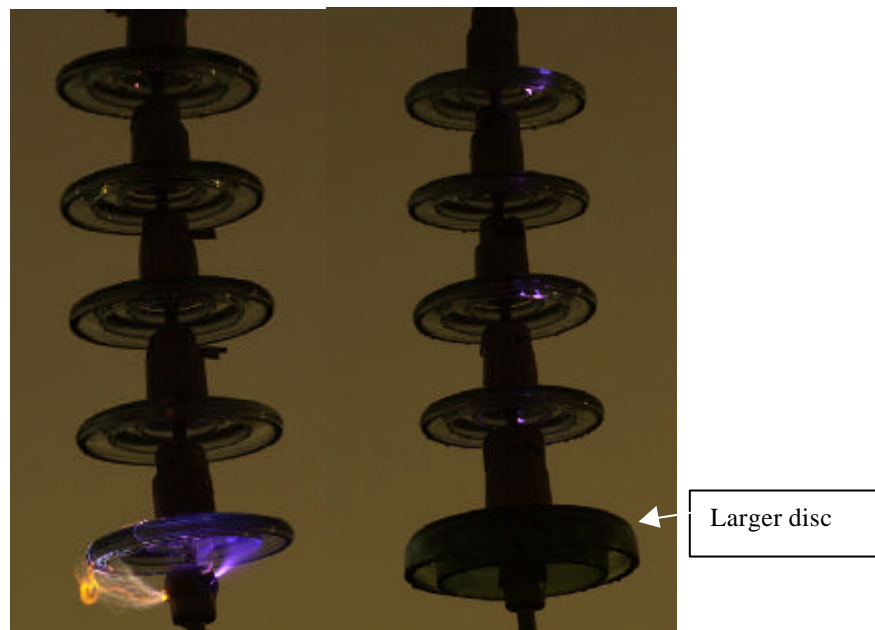
The aim of this test was to determine the effect of inserting a dry disc into a string of uniformly, lightly polluted insulators. Although the effect of single disc flashover has been well-documented [2], the effect of inserting a larger disc has not (this test compared the two sizes of discs) (U120 and F16PDC)[2,3]. Figures 7 and 8 illustrate the comparison. The dry U120 flashed over whilst the dry F16PDC did not [2]. The voltage stress used for the tests was the same as that experienced in the field (15.33 mm/kV). It is clear from these tests that the higher dry AC flashover strength of the F16PDC (90 kVrms) prevents the flashover. This value is higher than that of the U120, which is 70 kVrms.

Figures 7 and 8: Uniformly Wetted/Polluted String With a Single Dry Disc on the End

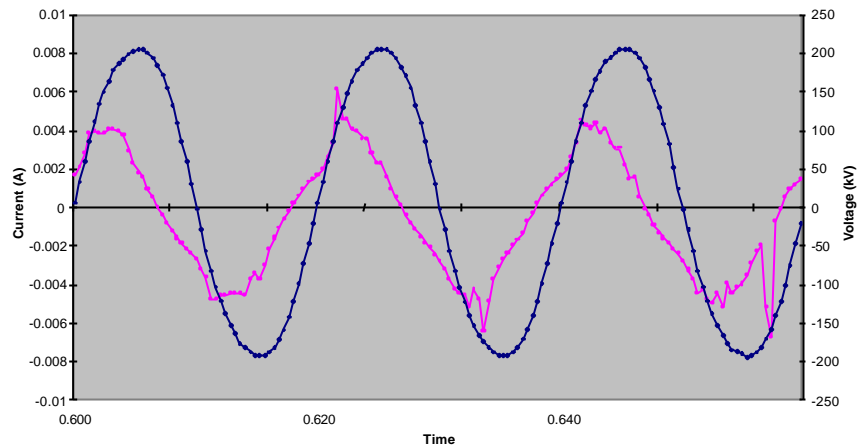
A typical waveform of a dry disc inserted into a wetted string is given in Figure 9. It is evident from the waveform that the resultant leakage current is dominated by the capacitive current, which is phase shifted (in comparison to the voltage), and the magnitude of the current. The resultant leakage current is low as expected (5mA peak [3]).

Figure 9: Typical Leakage Current and Voltage Waveform for Insulator Strings Shown in Figures 9 and 10
